SPALL REPAIRS IN PCC PAVEMENTS CONDITION 2 – LOCALIZED SPALLS TECHNICAL REPORT

Prepared by: Maintenance Department
Servicios de Aeropuertos Bolivianos S.A.
El Alto International Airport
January 2005

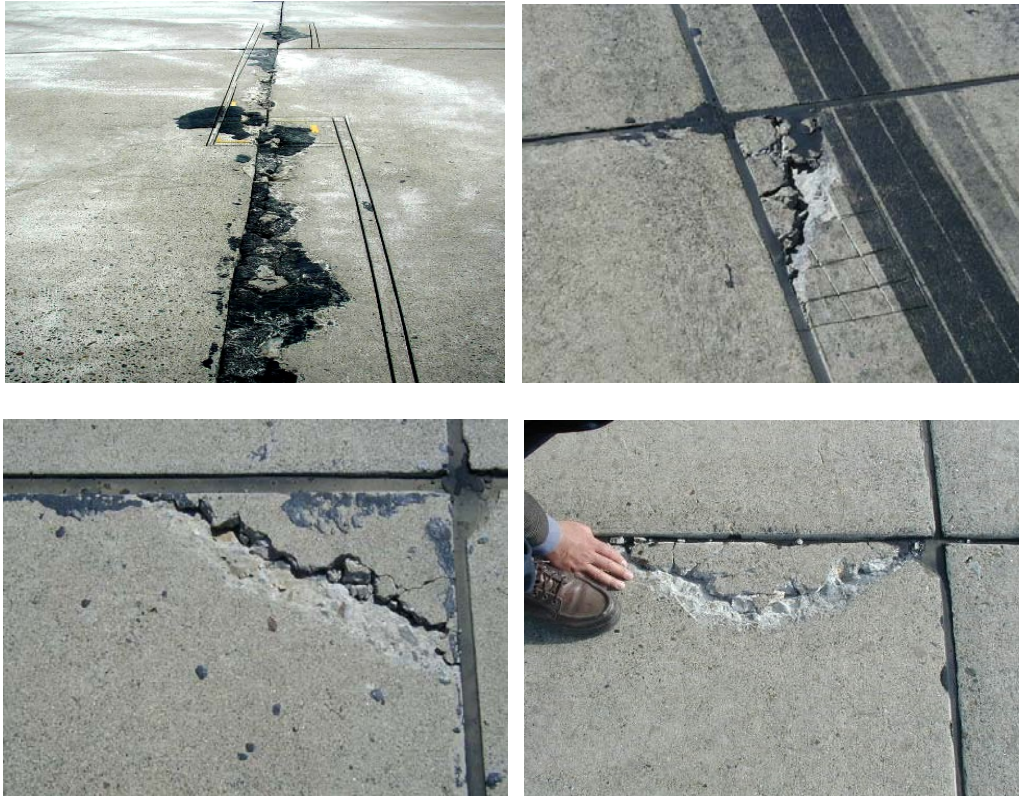
undertake the repairs for this kind of deficiency responds to the risk of damage to the tires and the risk of FOD during aeronautical operations that they represent. The pictures in Figure 1 show examples of this pavement condition.

Figure 1: Examples of Condition 2 in slabs of PCC pavement

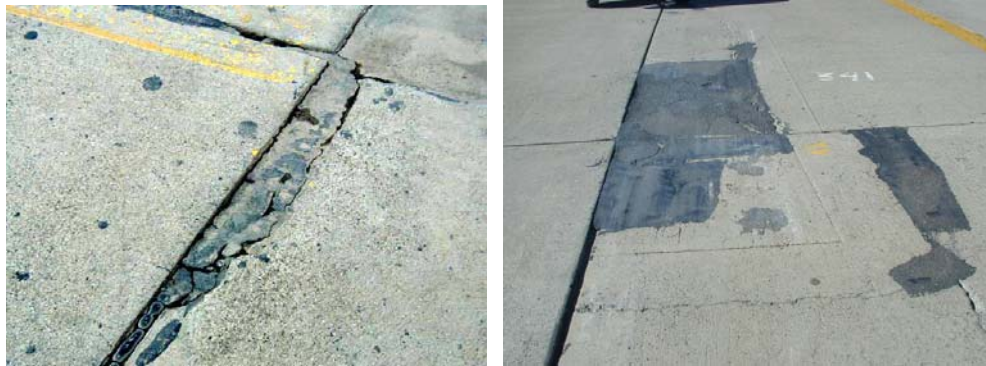
Hot asphalt mixtures products have a sealed matrix which, once applied to the PCC pavement, produce an impervious interface. This interface does not allow the underlying concrete to “breathe” when exposed to rains or maintenance activities (such as rubber removal). As a result of these conditions, the surface of concrete in direct contact with the asphalt patch will saturate compromising, eventually, the bond between both materials, and the patch will break loose. Figure 2 shows the results of this kind of incompatibility.

Figure 2: Failure of hot asphalt repairs on PCC pavement

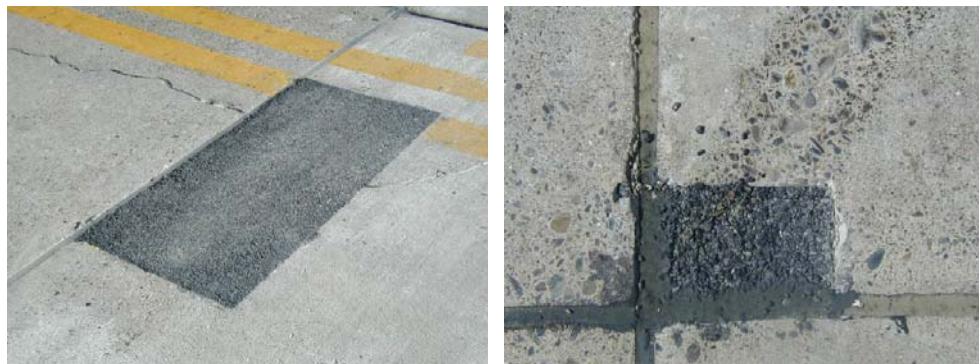
The application of cold asphalts proved to be an excellent alternative for emergency repairs only. These materials allow for their application even in spalls with standing water, and this is the type of flexibility that an emergency repair requires. However, the properties of these materials do not allow proper compaction with standard equipment (especially at the perimeter of the repair) and by no means can the compacting effort simulate the load of a landing gear. In addition, this alternative has virtually no resistance to torsion loads, very common y aeronautical maneuvers. The combination of the two previously described conditions will lead to the eventual disintegration of the patch in pieces of different sized that could represent the risk of FOD.

Figure 3: Failure of cold asphalt repairs; settlement due to heavy traffic loads and tearing of patch due to torsion

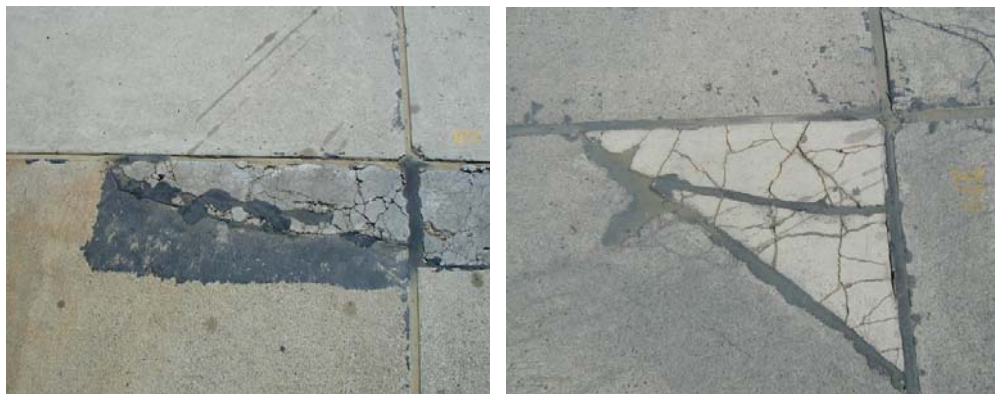
Very encouraging results were obtained during the early stages testing these materials. Light traffic (pick-ups and catering trucks) could be open in the area repaired within the first three hours of application. Unfortunately, the lack of resistance of these materials to the freeze/thaw cycles (El Alto) and to the sudden changes in temperature due to cold fronts (Virus Viru) became evident. It took only three months before the need to replace the repair was obvious. Five materials of similar characteristics and different brands were used with the same results in all cases. Figure 3 shows pictures of patches that failed after being exposed to environmental conditions with temperature changes ranging between 20 and 25 degrees Centigrade.

Figure 4: Deterioration process of cement based materials due to sudden ambient temperature changes

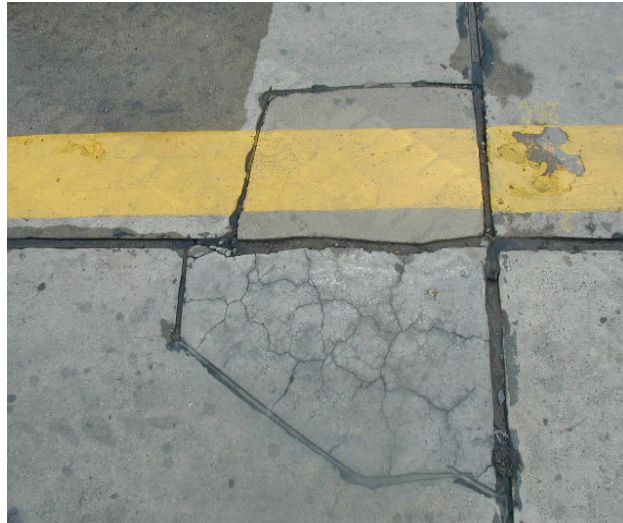
Due to the results obtained the search to determine the best product for long term repairs continued by the testing of epoxy compounds. It was determined that the high early strengths reached by this kind of materials (three different products were tested) would allow a rapid return to service for the infrastructure repaired. Before the deficiencies previously reported on cement based materials were identified, tests were performed simultaneously with epoxies and cement based materials. The picture in Figure 5 shows a location where adjacent corner spalls were repaired with different materials. After two months in service the cement based materials showed signs of deterioration already.

Figure 5: Comparison of durability between cement based materials and epoxy compounds

Based on the results obtained, it was determined to use epoxy compounds exclusively for the repair of slabs classified under Condition 2. The determination was made even though the cost per cubic meter of epoxies was close to be five times higher than that of cement based materials.

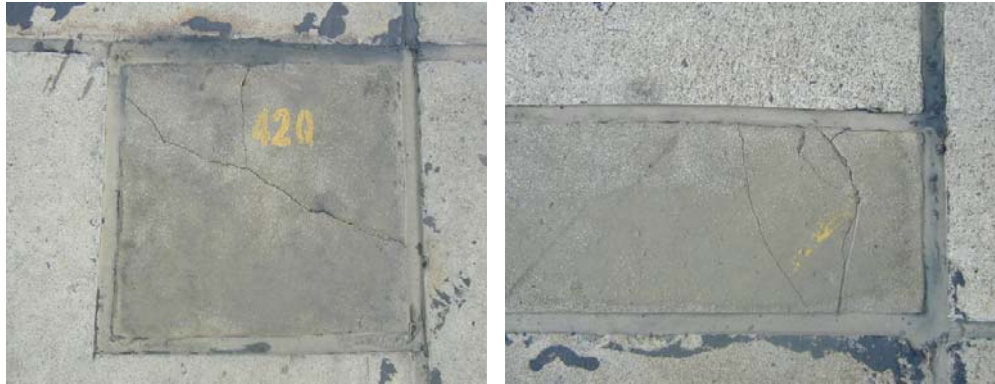
Subsequent monitoring of the epoxy compound repairs showed a clearly defined tendency for cracking within the first four months after the repair was completed. Figure 6 shows the conditions of repairs with epoxy compound when exposed to traffic and environmental conditions for an extended period.

It is evident that epoxy compounds yield not only better durability but also safer operational conditions even after cracking. However, the presence of cracks allows for water to flow under the pavement compromising the sub grade due to saturation. Similarly, non-compressive material accumulating in the cracks, combined with expansion processes due to high temperatures, will result in a continuous deterioration process in the repair.

During the early stages of testing these materials, it was observed that the perimeter between the PCC pavement and the epoxy compound cracked within the first week after the material was poured. In order to eliminate this cracking a joint was established and sealed at the vertical interface between both materials.

Figure 6: Cracking of patches completed with epoxy compounds

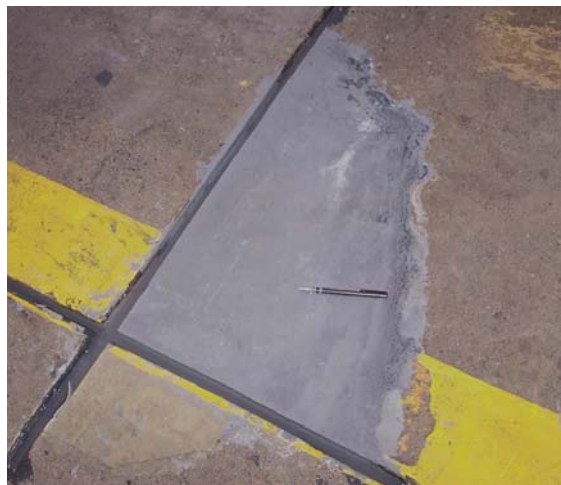
With the results obtained using repair materials available in the local market, it was determined to explore the possibility to obtain alternatives from the US market to continue searching for the best available option. By attending the pavement management and pavement condition seminar sponsored by ICAO in Lima, in November 2003, it was possible to establish contact with Mr. Don Simmons, sales manager from Ceratech, Inc. A small amount of products was ordered and imported. Tests in the field yielded excellent results, as shown in Figure 7. It can be observed, after four months, that the repair shows no signs of deterioration. The small epoxy compound patch at the adjacent corner shows cracking around the perimeter.

Figure 7: Repair completed using Pavemend

In addition to the results obtained, Pavemend has a very competitive cost when compared with the epoxy compounds (approximately 60% cheaper) and it will be used exclusively for this kind of repairs. Due to its properties, this material has been used in applications to correct pavement roughness due to settlements and to improve the skid resistance. The results of these tests will be subject for independent reports.
