# ekkomaxx™ *Case Study*

## GA DOT District 2 I-16 Eastbound Right Lane Dublin GA..... ekkomaxx® Full Depth Slab Replacement

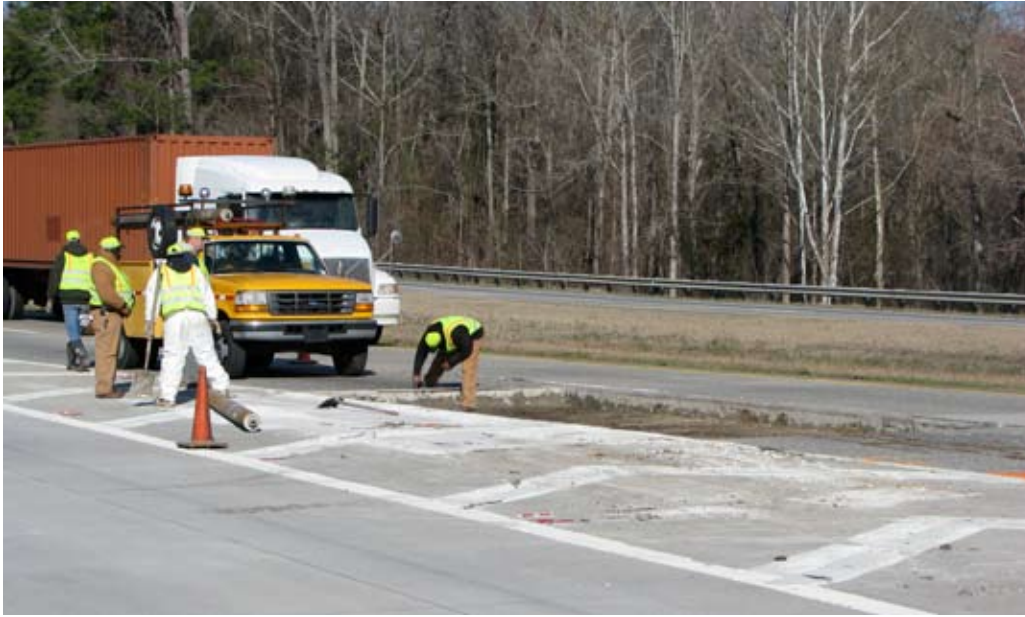
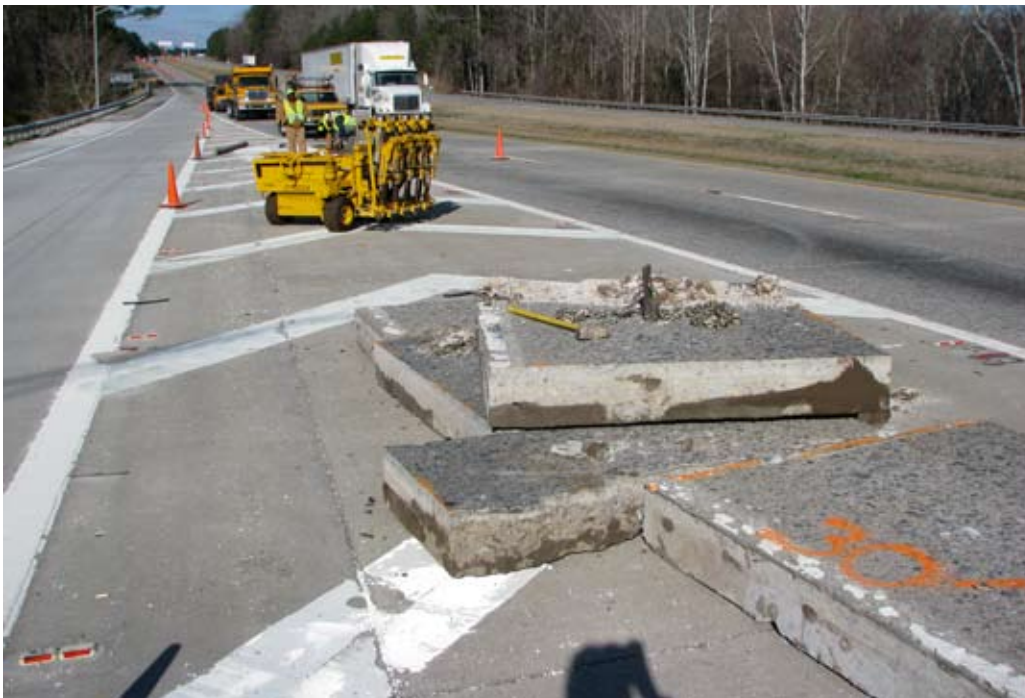
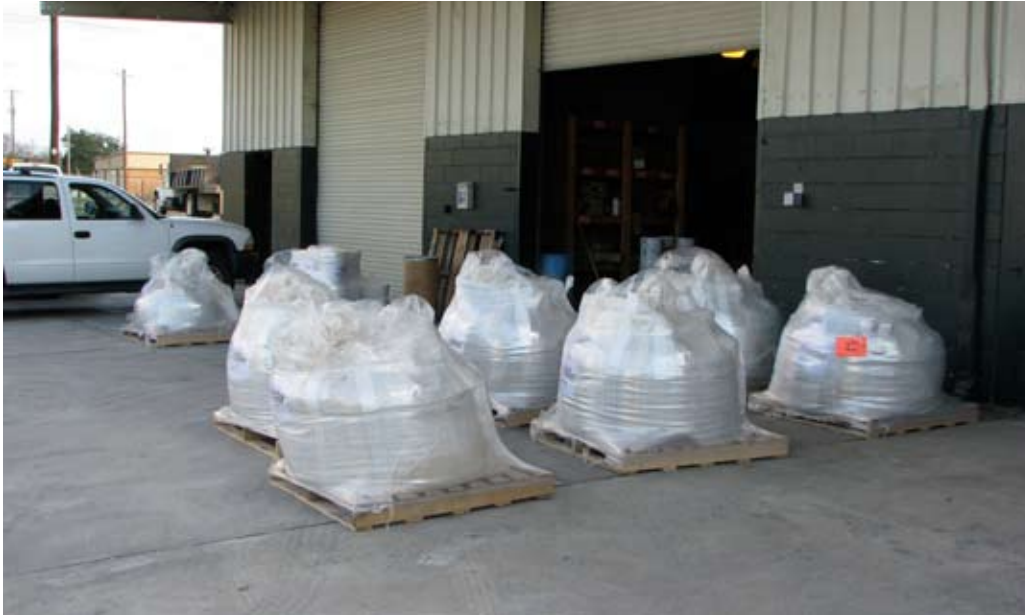
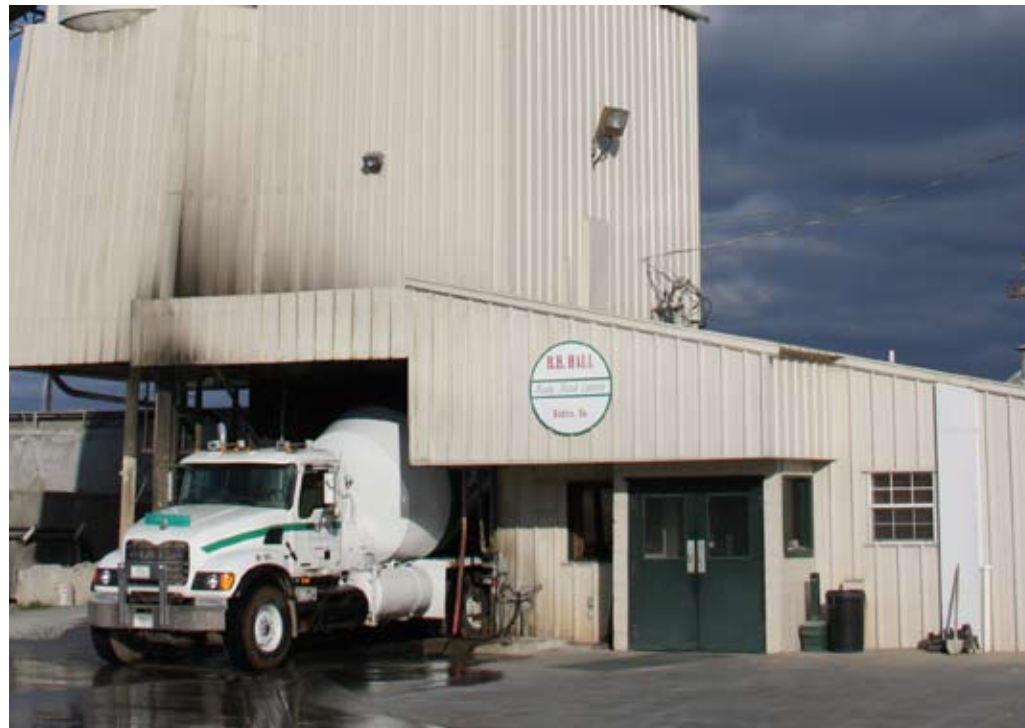
On February 27, 2008, the Georgia Department of Transportation executed placement of 12 cubic yards of **ekkomaxx**®, CERATECH's high performance Non-Portland cement concrete. An area of failed slab sections measuring approximately 30 x 12 x 10" on Hwy I-16 near Dublin, Georgia with large transverse and longitude cracking and with 2-3" of settlement was removed by GA DOT crews.

Once the failed slabs were removed, inspection of the sub-grade revealed excessive moisture and disturbed material. A load of crushed angular stone was spread in a 3" lift across the underlying soil and then compacted prior to the placement of **ekkomaxx**®. This would prevent future settlement in the area to be repaired. A gang drill was then used to re-establish dowel holes across all transverse joints. New epoxy coated dowel bars were inserted thus completing the site preparation.
