# ekkomaxx™ *Case Study*

## GA DOT District 2 I-16 Eastbound Right Lane Dublin GA..... ekkomaxx® Full Depth Slab Replacement

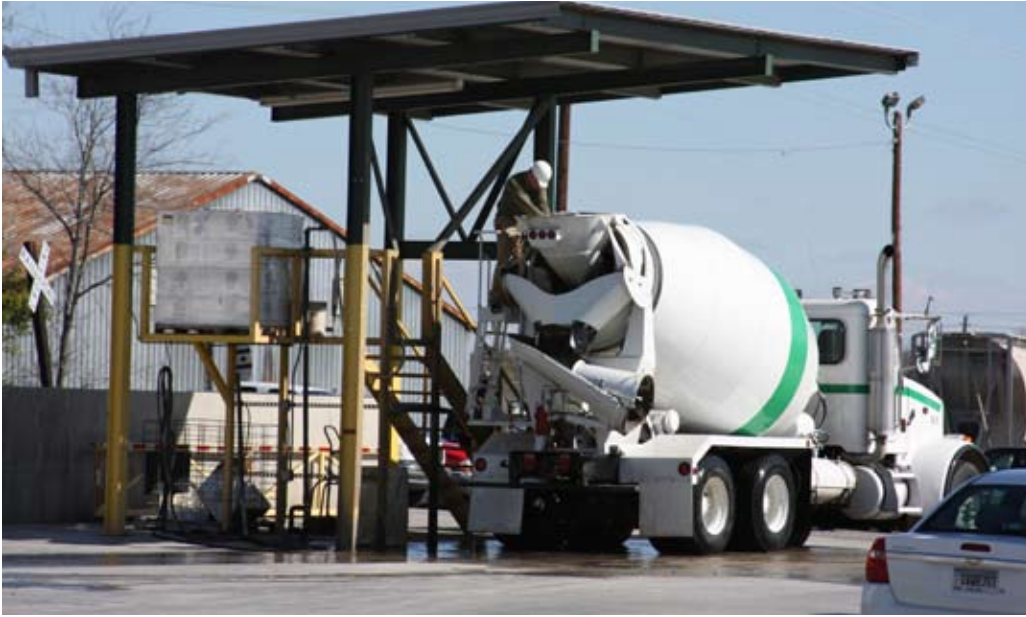
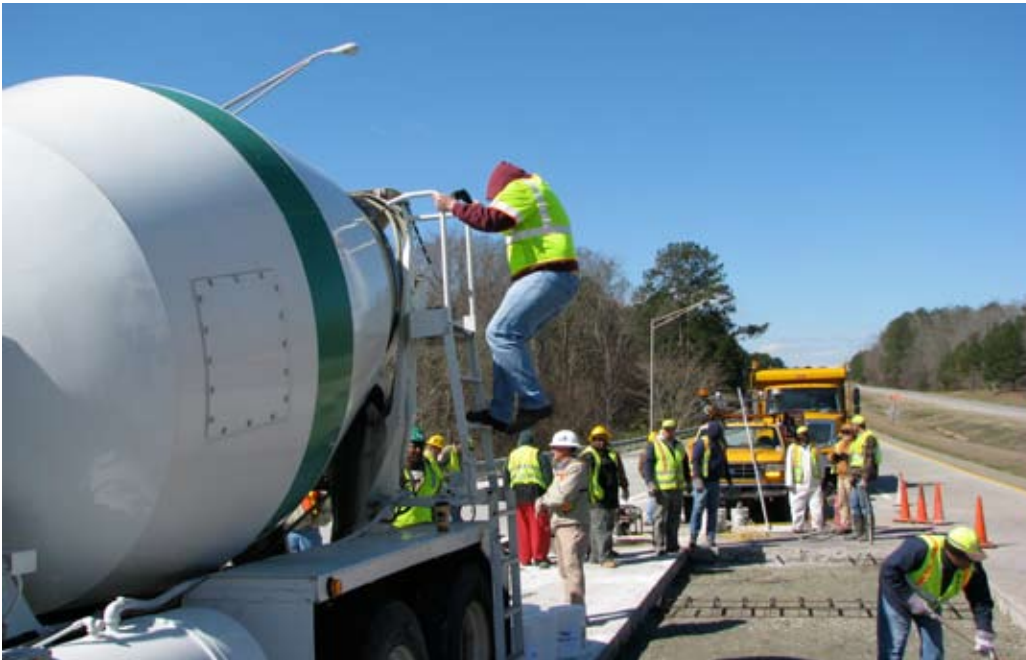
The drum turned at mixing speed (16 - 18 rpm) during each phase of the batching process, with each phase lasting 3-5 minutes on average. Weather during batching was clear and sunny with ambient temperatures ranging from 50F-60F. While batching the first truck, the plant received a call from the crew onsite to delay delivery until 1130 due to mechanical problems with the dowel bar machine. Batching of the second truck was delayed by approximately 40 minutes and batching of the first truck continued, since it was near com-

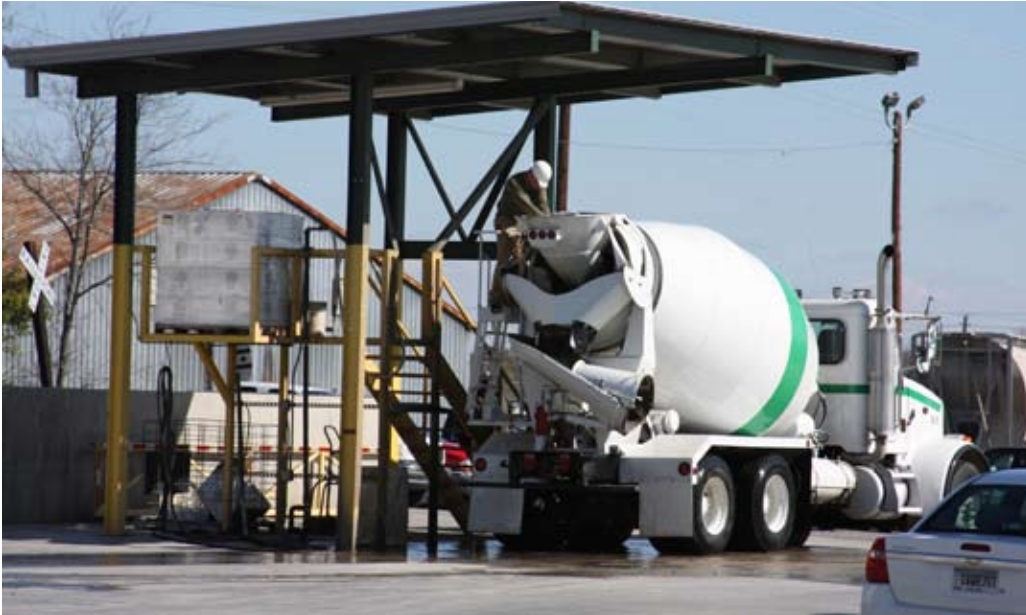
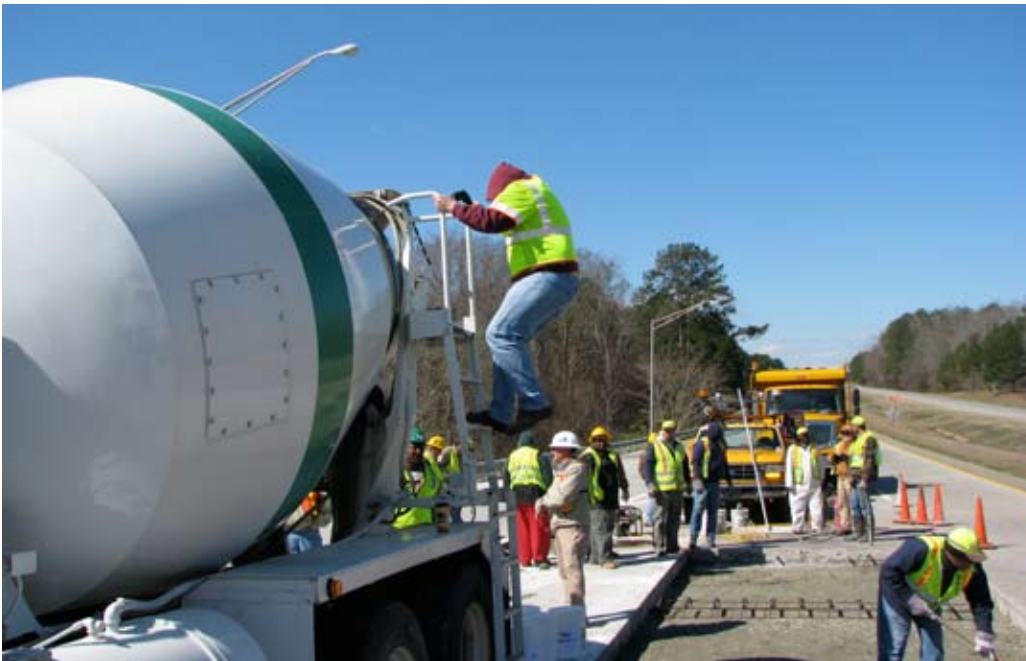
Site conditions at time of placement : ambient temp 42°F, surface temp 43°F. 11mph winds with gusts to 20 mph. Material was mixed for 6 minutes after addition of **ekkomaxx®** activator admixture. Material was mixed for an additional minute and discharged into the repair area.

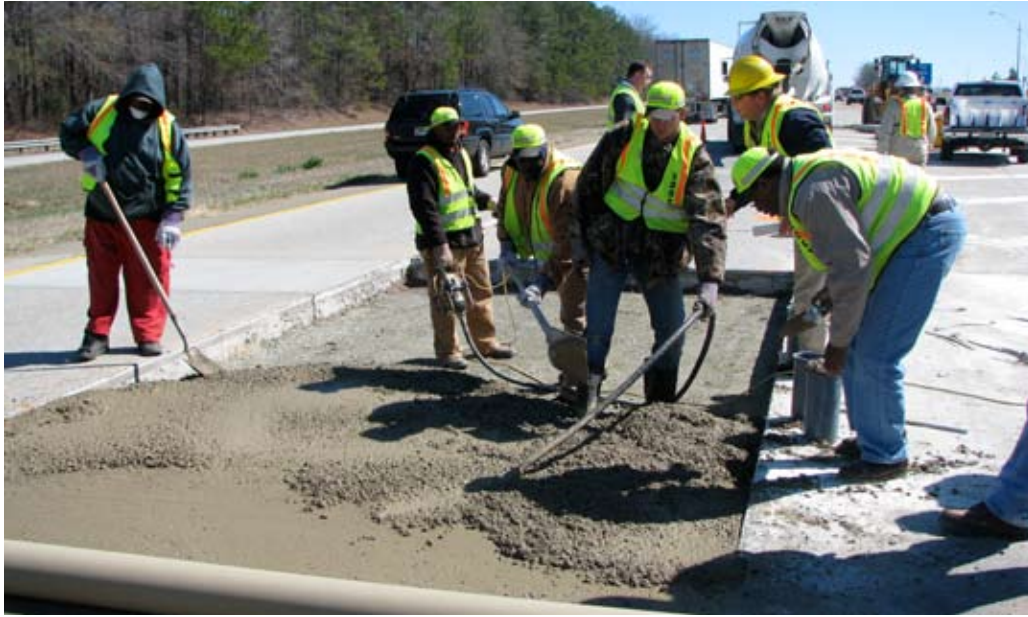
The GA DOT crew utilized shovels, pencil vibrator, and vibratory roller screed to consolidate the material. A bull float and hand trowels were used for finishing techniques. A push broom was also applied to provide texture to the surface.

After finishing the material, the crew applied a coat of W. R. Meadow's curing compound with a handheld sprayer.

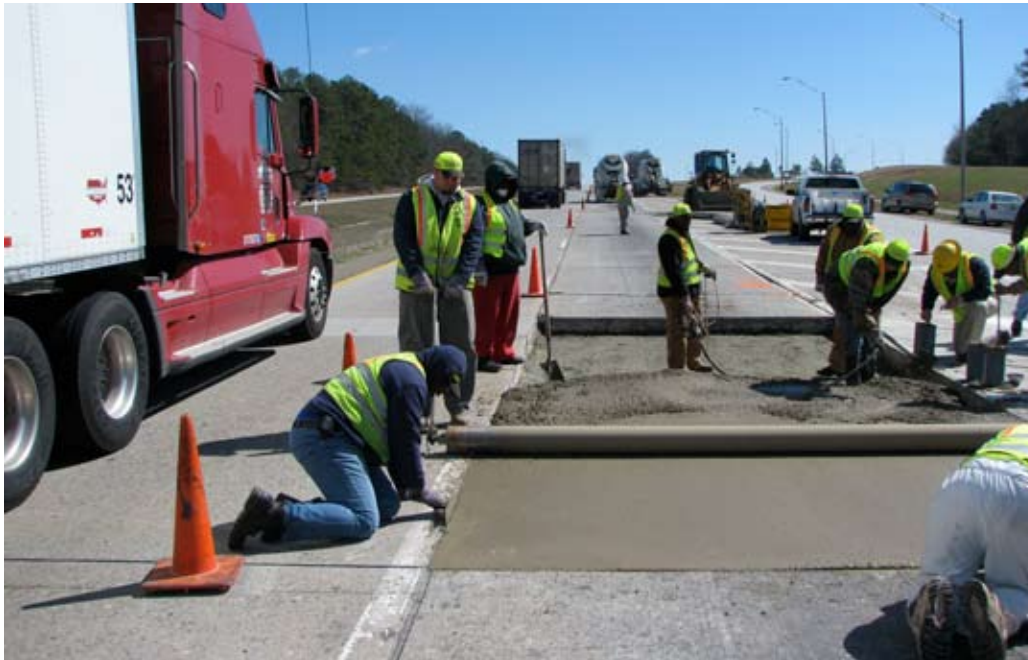
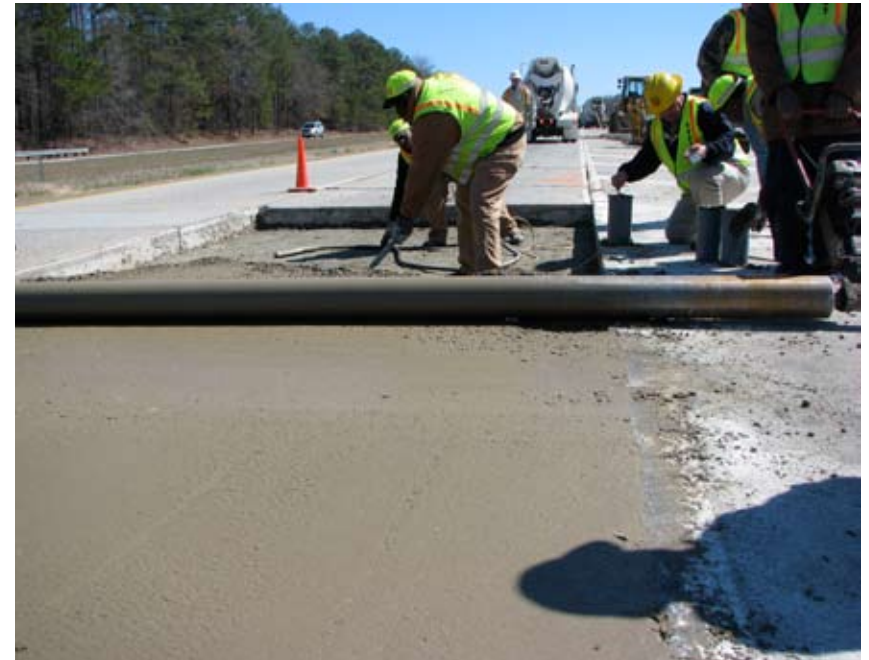
The crew supervisor was advised to re-establish all joints to full depth no sooner than 4:30 PM . He was also advised not to open up the repaired area sooner than 5:30 PM ( just 5 hours after placement ) Temperature of the material at that time was 94°F.
